# ARCHITECTURAL TILES

*Conservation and Restoration*

LESLEY DURBIN

*Second edition*

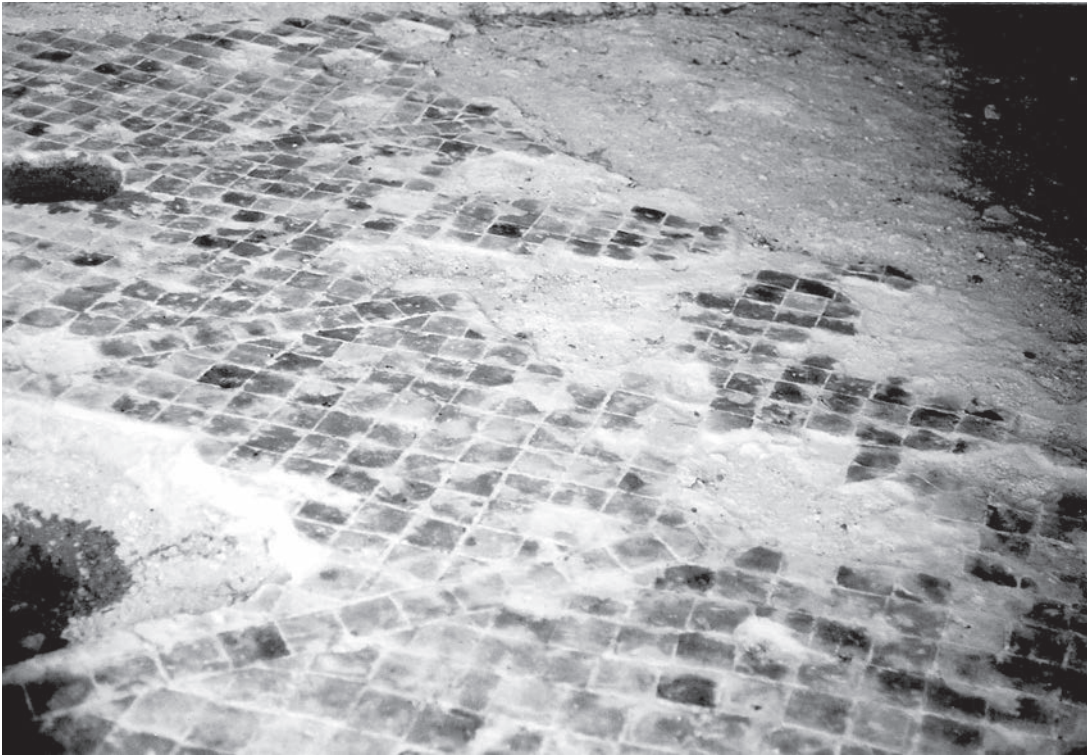
*Figure 1.2* Part of the thirteenth-century refectory floor at Denny Abbey, Cambridgeshire, showing the diagonal format with single lines of tiles inserted.

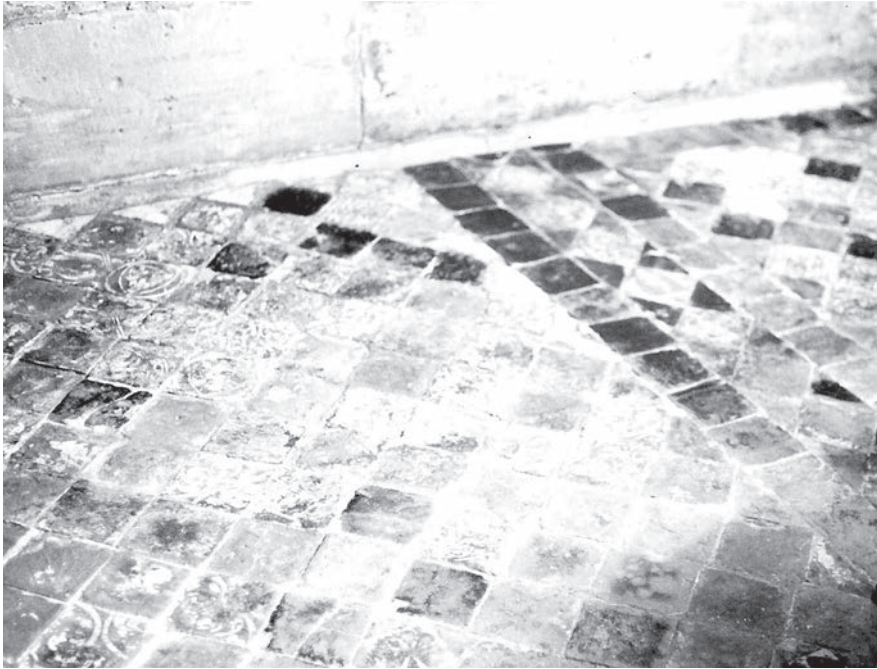
*Figure 1.3* Part of the thirteenth-century floor in the suite of guest chambers in Guy's Tower, Warwick Castle, showing the diagonal format with double tramlines of inserted tiles.

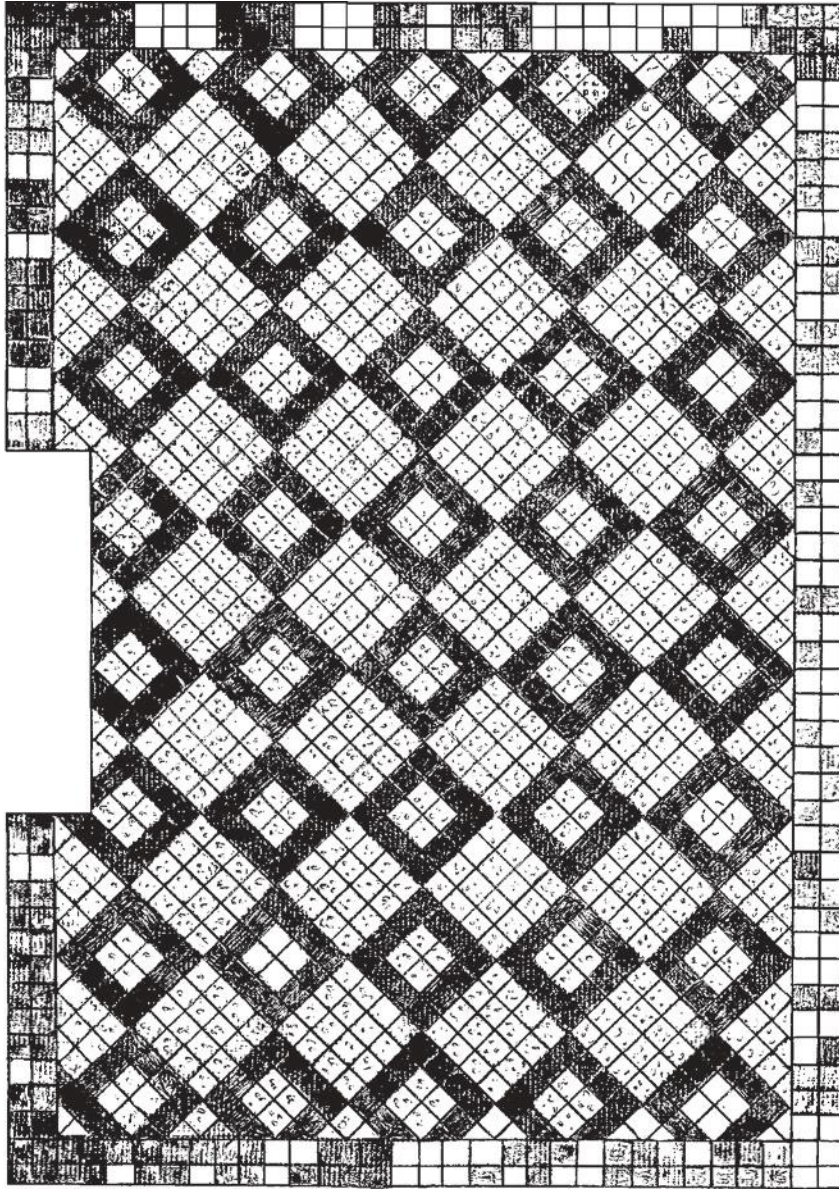
Figure 1.4 Diagram of the Canynge pavement, British Museum, a diagonal format of groups of 16 and 4 decorated tiles surrounded by plain dark tiles.

A summary of studies of medieval pavement design, particularly the work carried out by Elizabeth Eames at the British Museum in the 1950s and 1960s, shows that large tile pavements were often laid in diagonal fashion, while smaller pavement areas were laid square on. Both the pavement in the small refectory at Cleeve Abbey and the Canynoges pavement (fifteenth century) found in Bristol, but now in the British Museum, demonstrate this format. Two lesser-known pavements – the refectory pavement at Denny Abbey (thirteenth century) (Figure 1.2) and the guest room floor in Guy's Tower, Warwick Castle (early fourteenth century) (Figure 1.3) – also demonstrate the same format with the addition of tramlines of tiles at intervals laid square on. Diagonal configurations are often arrangements of 16, 9, or 4 individually patterned tiles which make up a complete design surrounded with single rows of plain dark glazed tiles (Figure 1.4).

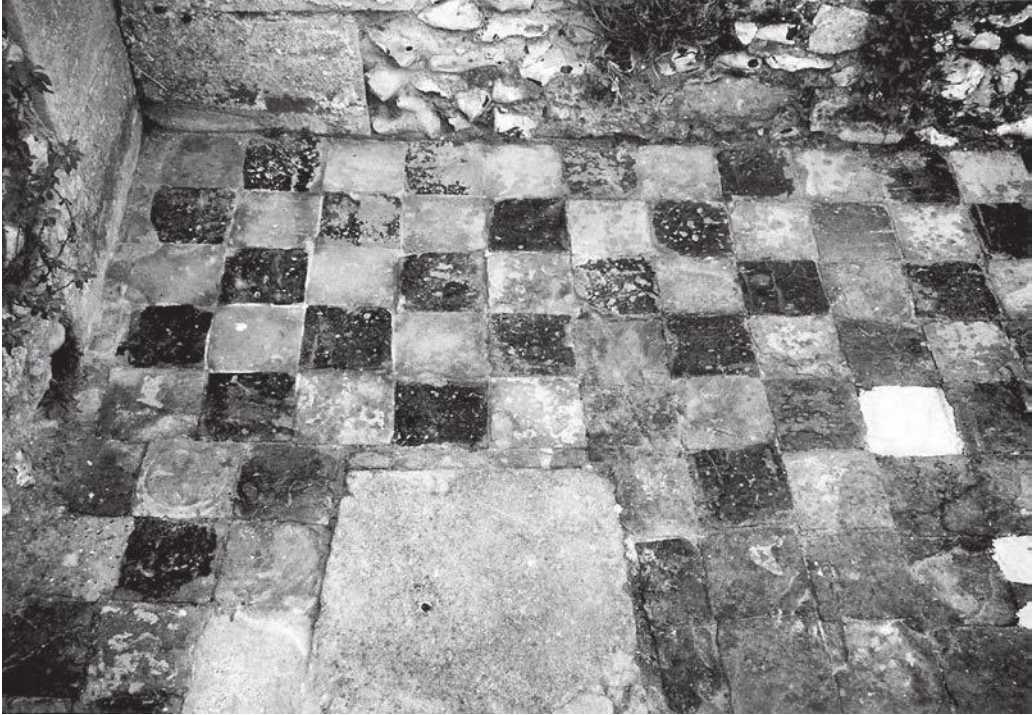
Figure 1.5 Checkerboard format found at Thetford Abbey, Norfolk.

Plain tiles set in square-on fashion were often in chequerboard configuration of dark green or black and plain yellow (Figure 1.5). Small pavements of square-on tiles are found arranged in panels
